TWR-17548 Volume II

FLIGHT SET 360L009 (STS-36)
CASE AND SEALS COMPONENT FINAL REPORT

NOVEMBER 1990

***Thiokol* CORPORATION**
SPACE OPERATIONS

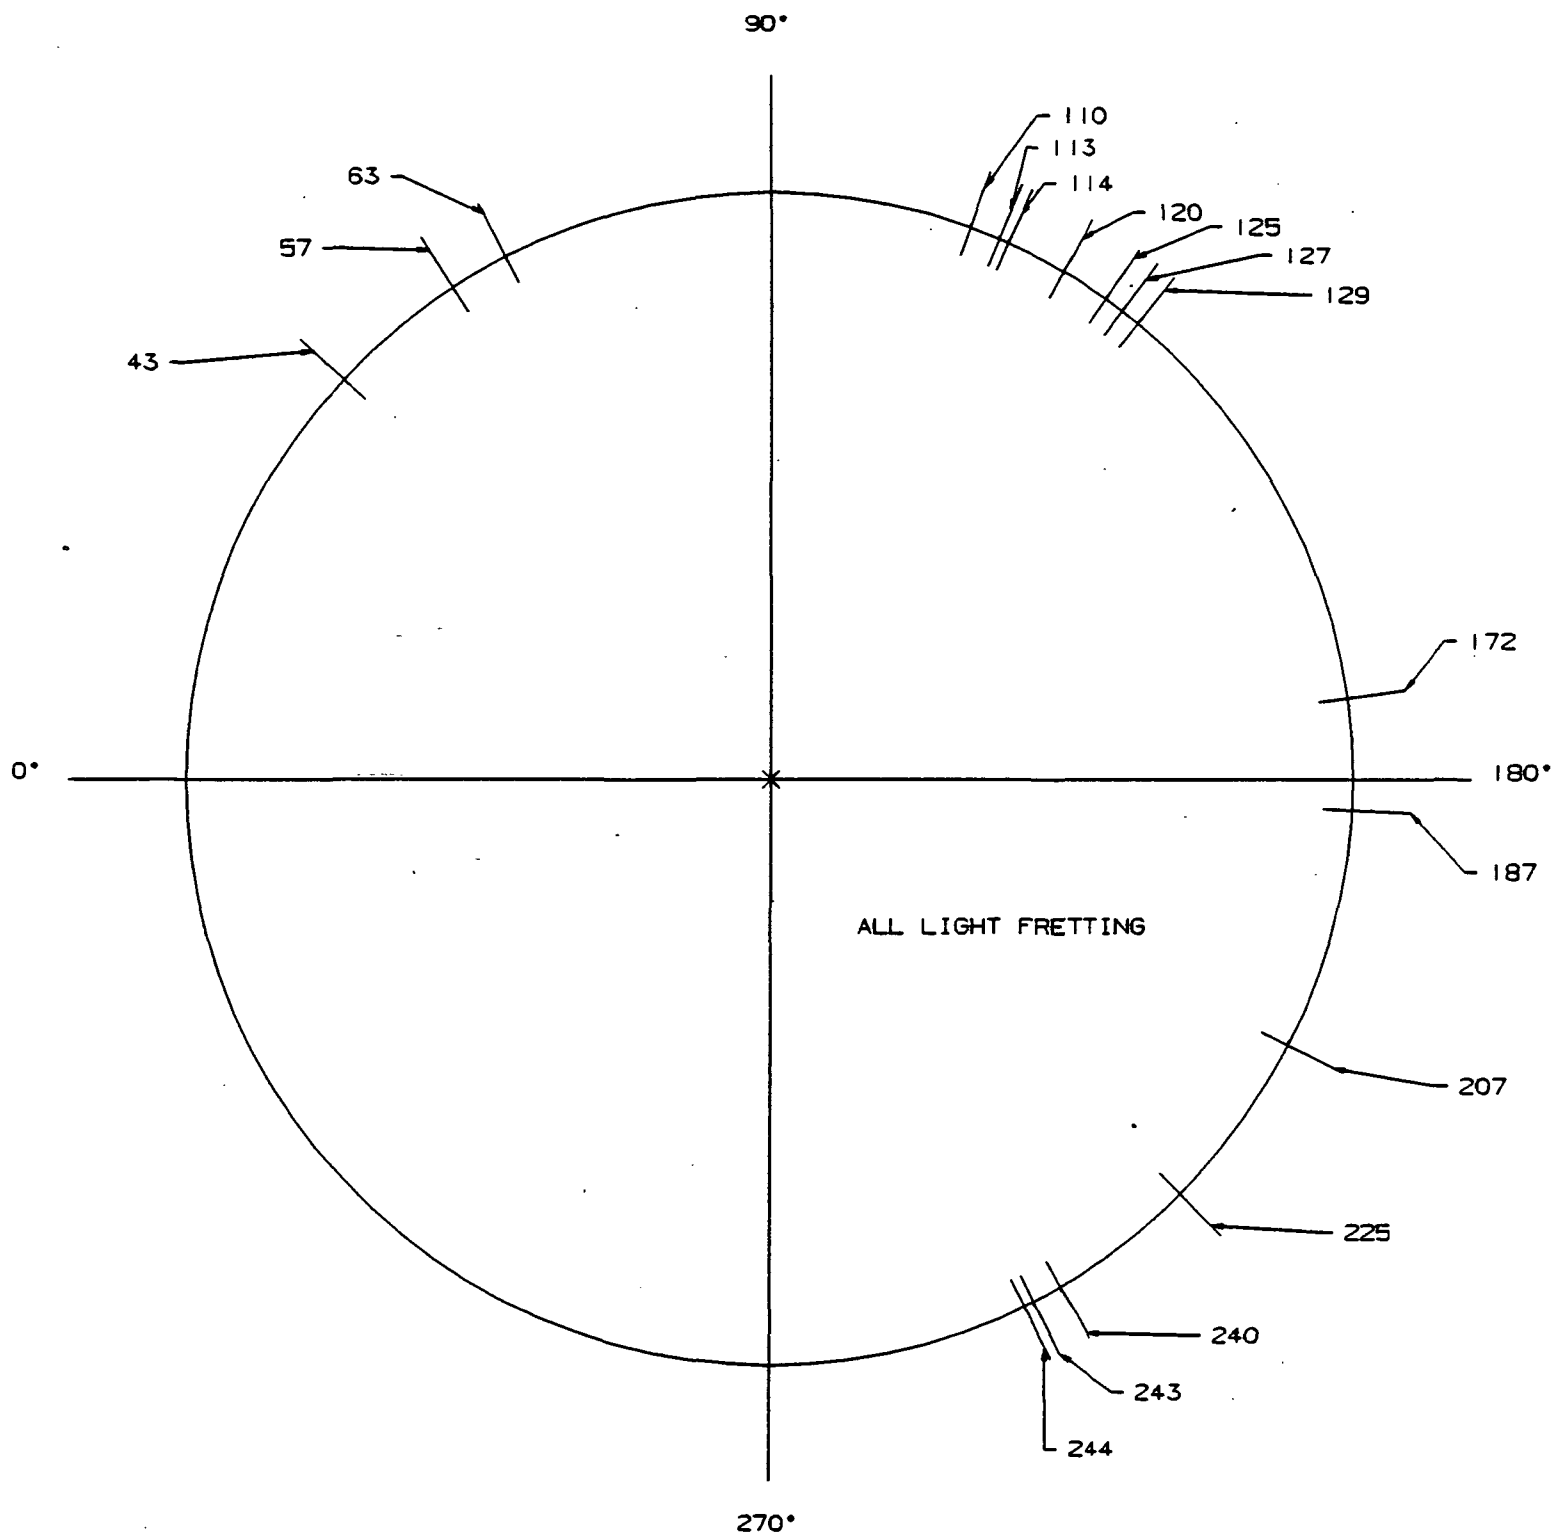
Figure 7 LH Forward Field Joint Fretting

Assessment of the metal components found light fretting at 43, 57, 62, 110 to 129, 172, 187, 207, 243, and 244 degrees. No medium

or heavy fretting was found. Figure 7 gives a detailed view of the fretting.

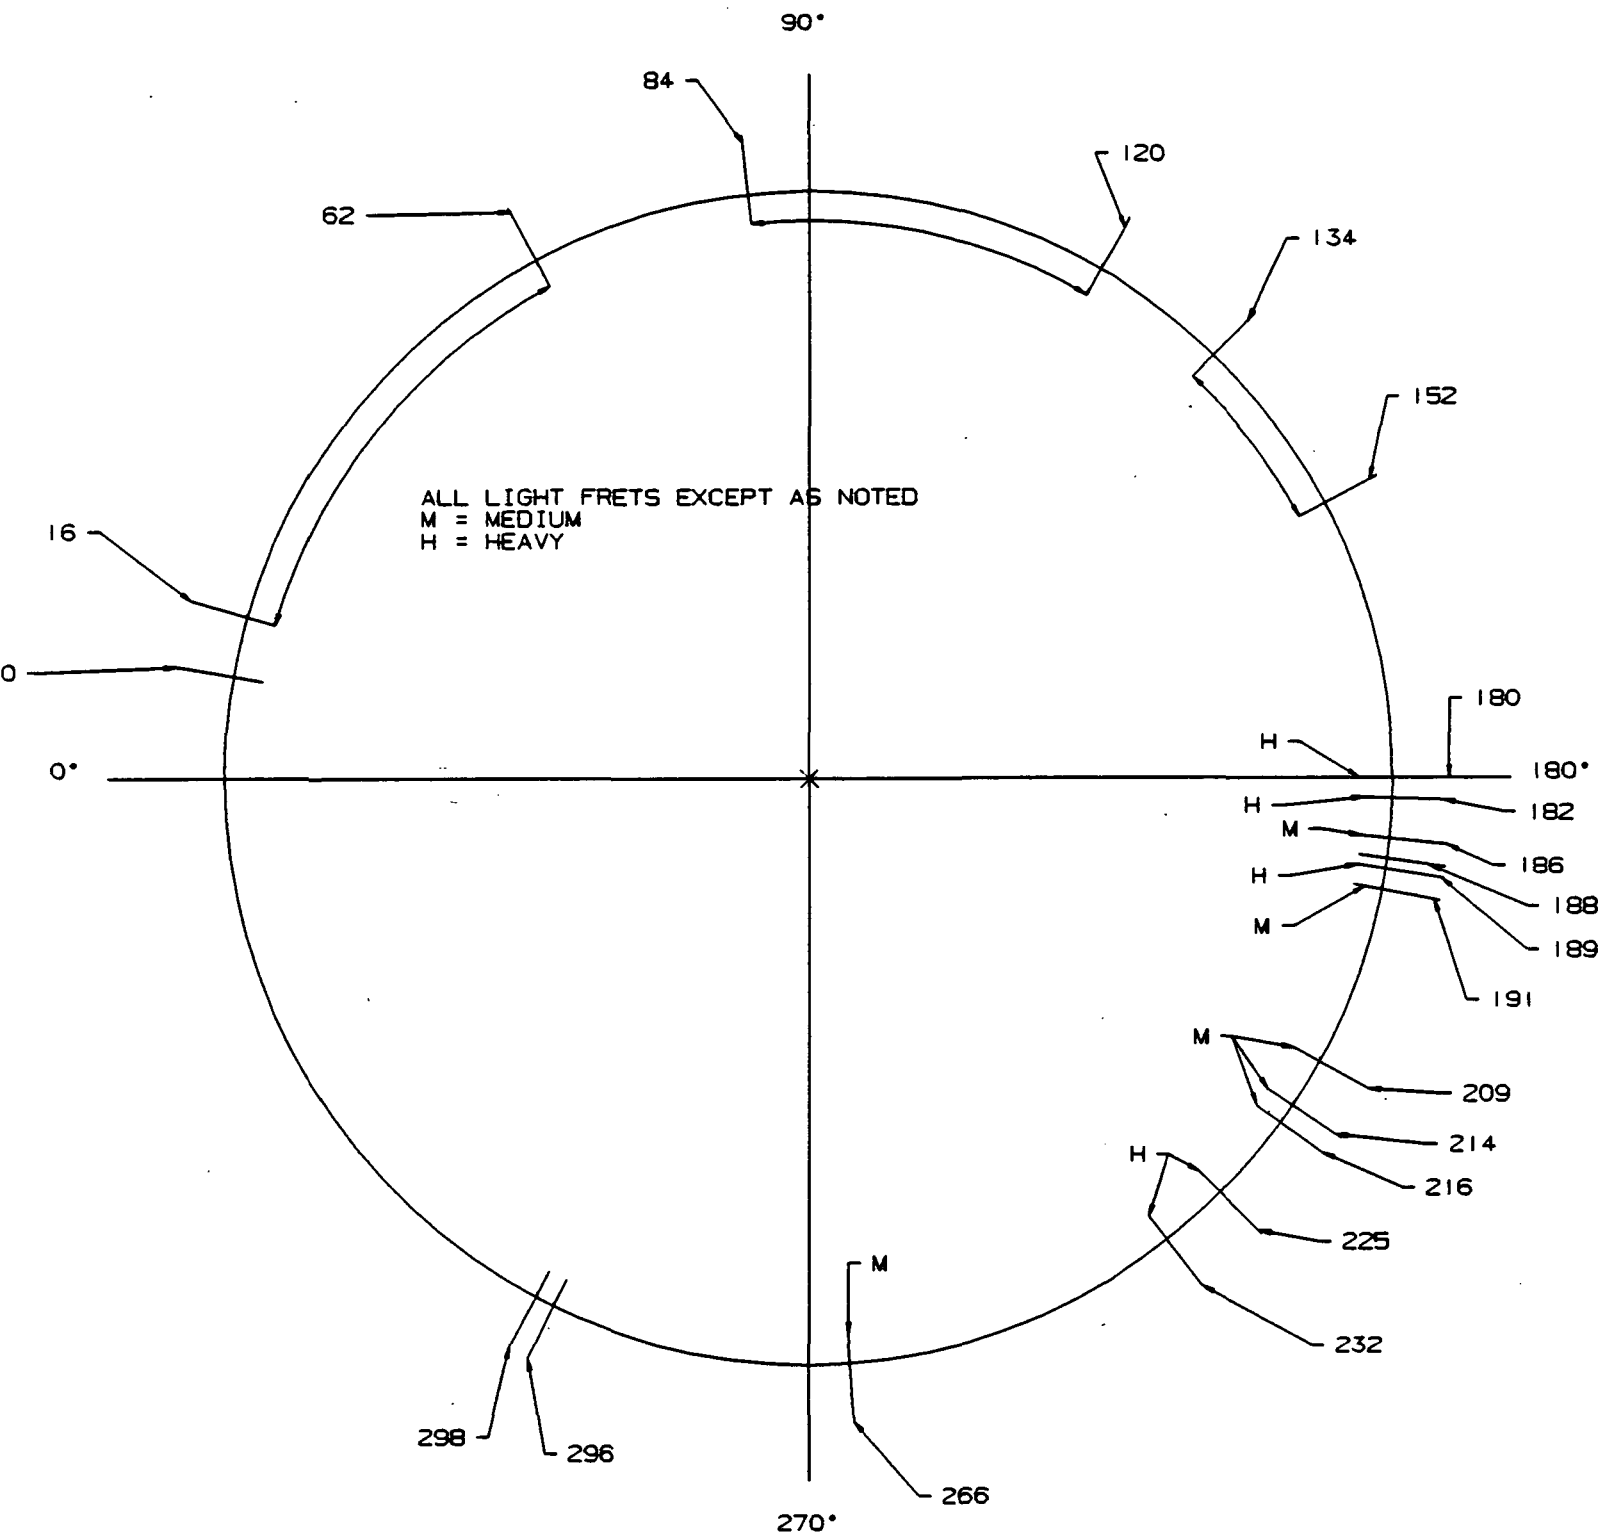
Figure 8 LH Center Field Joint Fretting

LH/CTR Intermittent light fretting around most of the joint with concentrations of moderate (0.003 to 0.005 inch deep) and heavy (>0.005 inch deep) fretting between 180 and 300 degrees. A 0.008 inch deep fret was found at 225 degrees.

Assessment of the metal components found intermittent light fretting from 10 to 300 degrees. Concentrations of medium and heavy fretting were found from 180 to 300 degrees. One 0.008 inch deep fret was located at 225 degrees. Figure 8 gives a detailed view of the fretting.

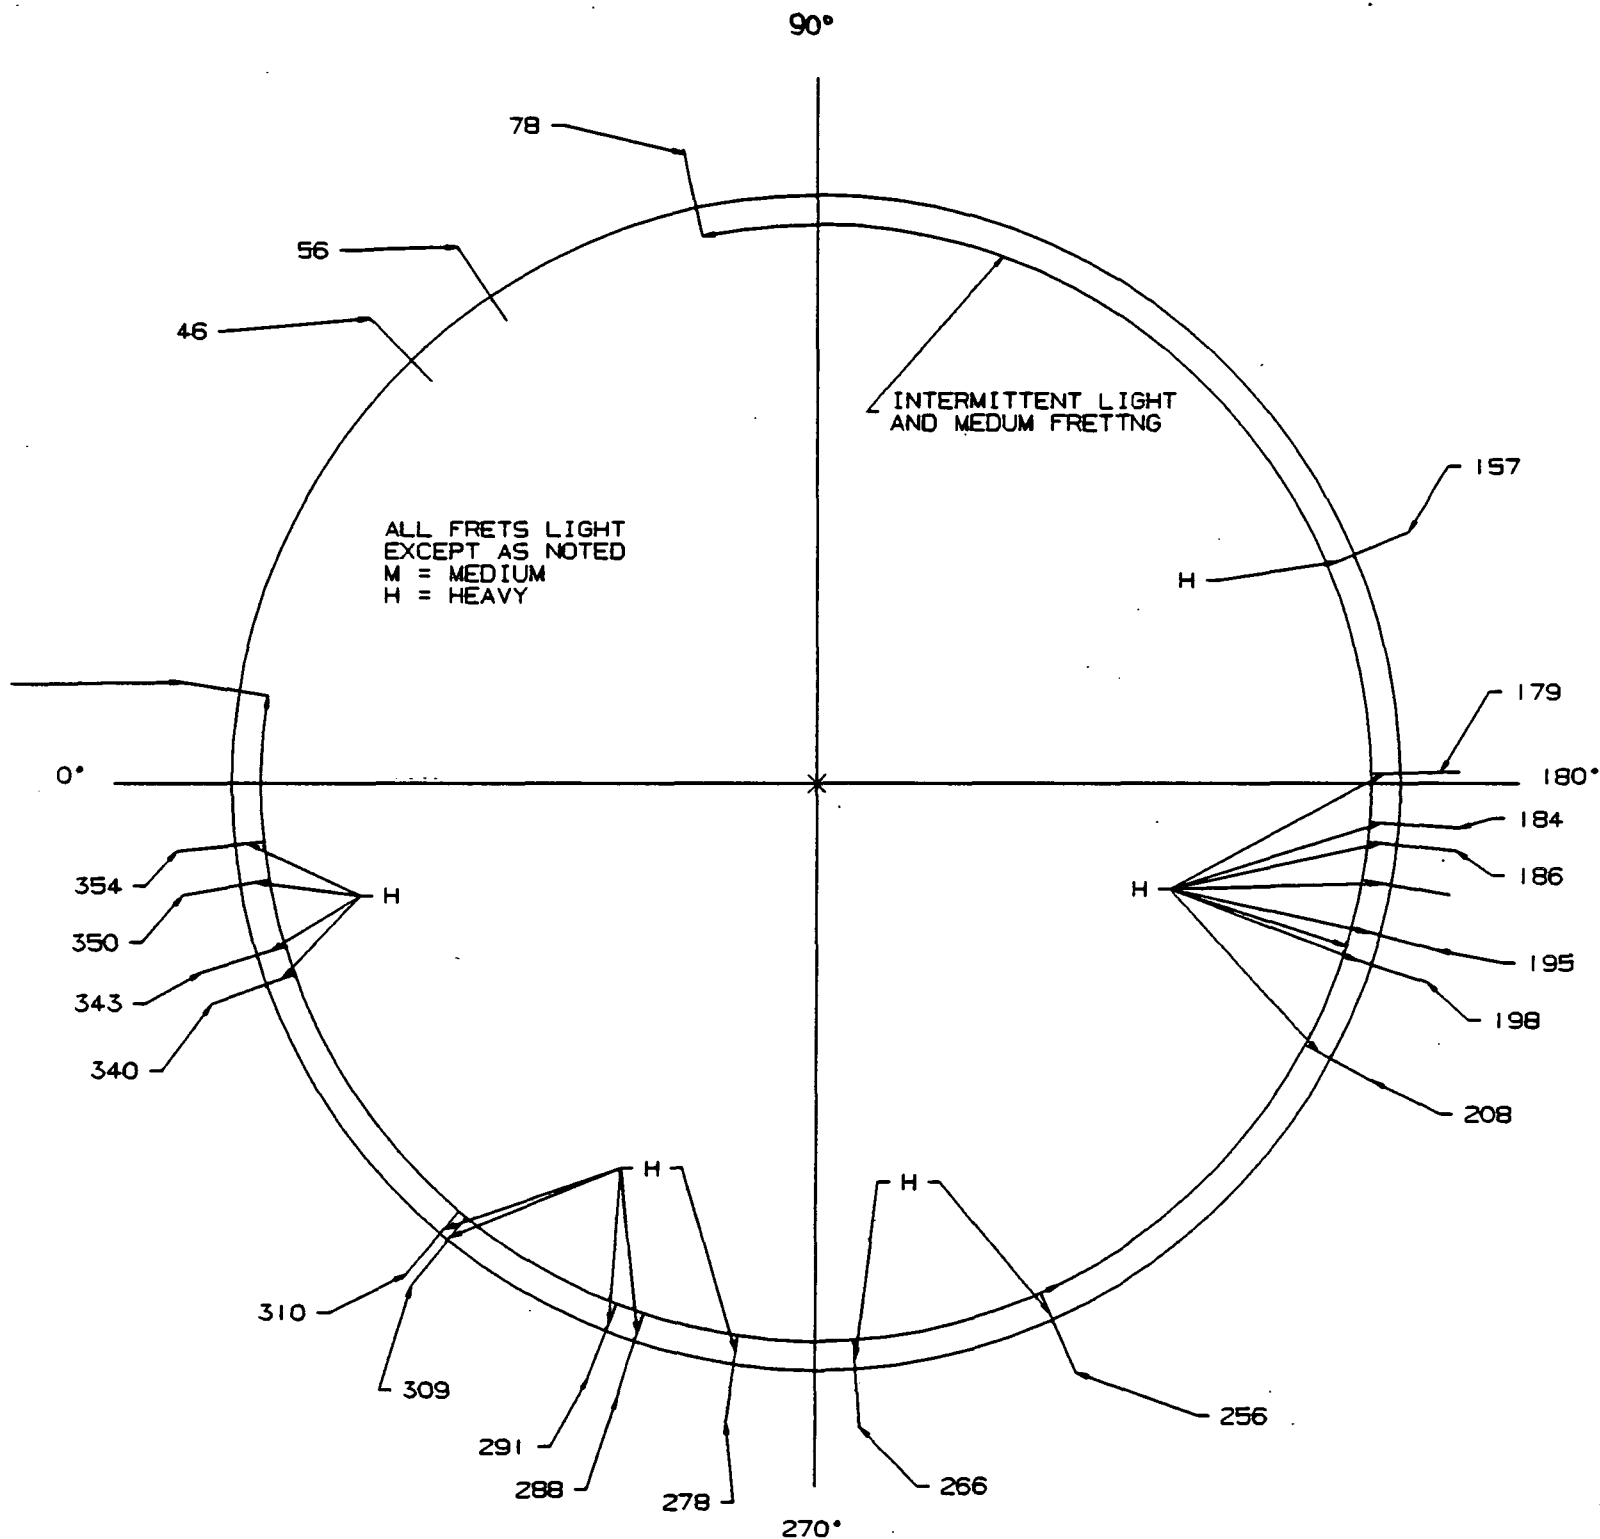
Figure 9 LH Aft Field Joint Fretting

LH/AFT Intermittent light fretting around most of the joint with concentrations of moderate (0.003 to 0.005 inch deep) and heavy (>0.005 inch deep) fretting from 135 through 0 to 9 degrees. Two 0.009 inch deep frets were found at 195, and 350 degrees and a 0.011 inch deep fret at 278 degrees.

Assessment of the metal components found light fretting around the entire circumference except between 9 to 46, and 56 to 116 degrees. Medium and heavy fretting was present from 135 through zero to nine degrees. Two heavy frets of 0.009 inch deep fret are located at 195 and 350 degrees. Also, a 0.011 inch deep fret was found at 278 degrees. Figure 9 gives a detailed view of the fretting. This joint, both clevis and tang had flown on RSRM-2 (STS-27), had been previously fretted and repaired. Fretting was found at the edges of repaired areas but not in any areas where metal was removed.

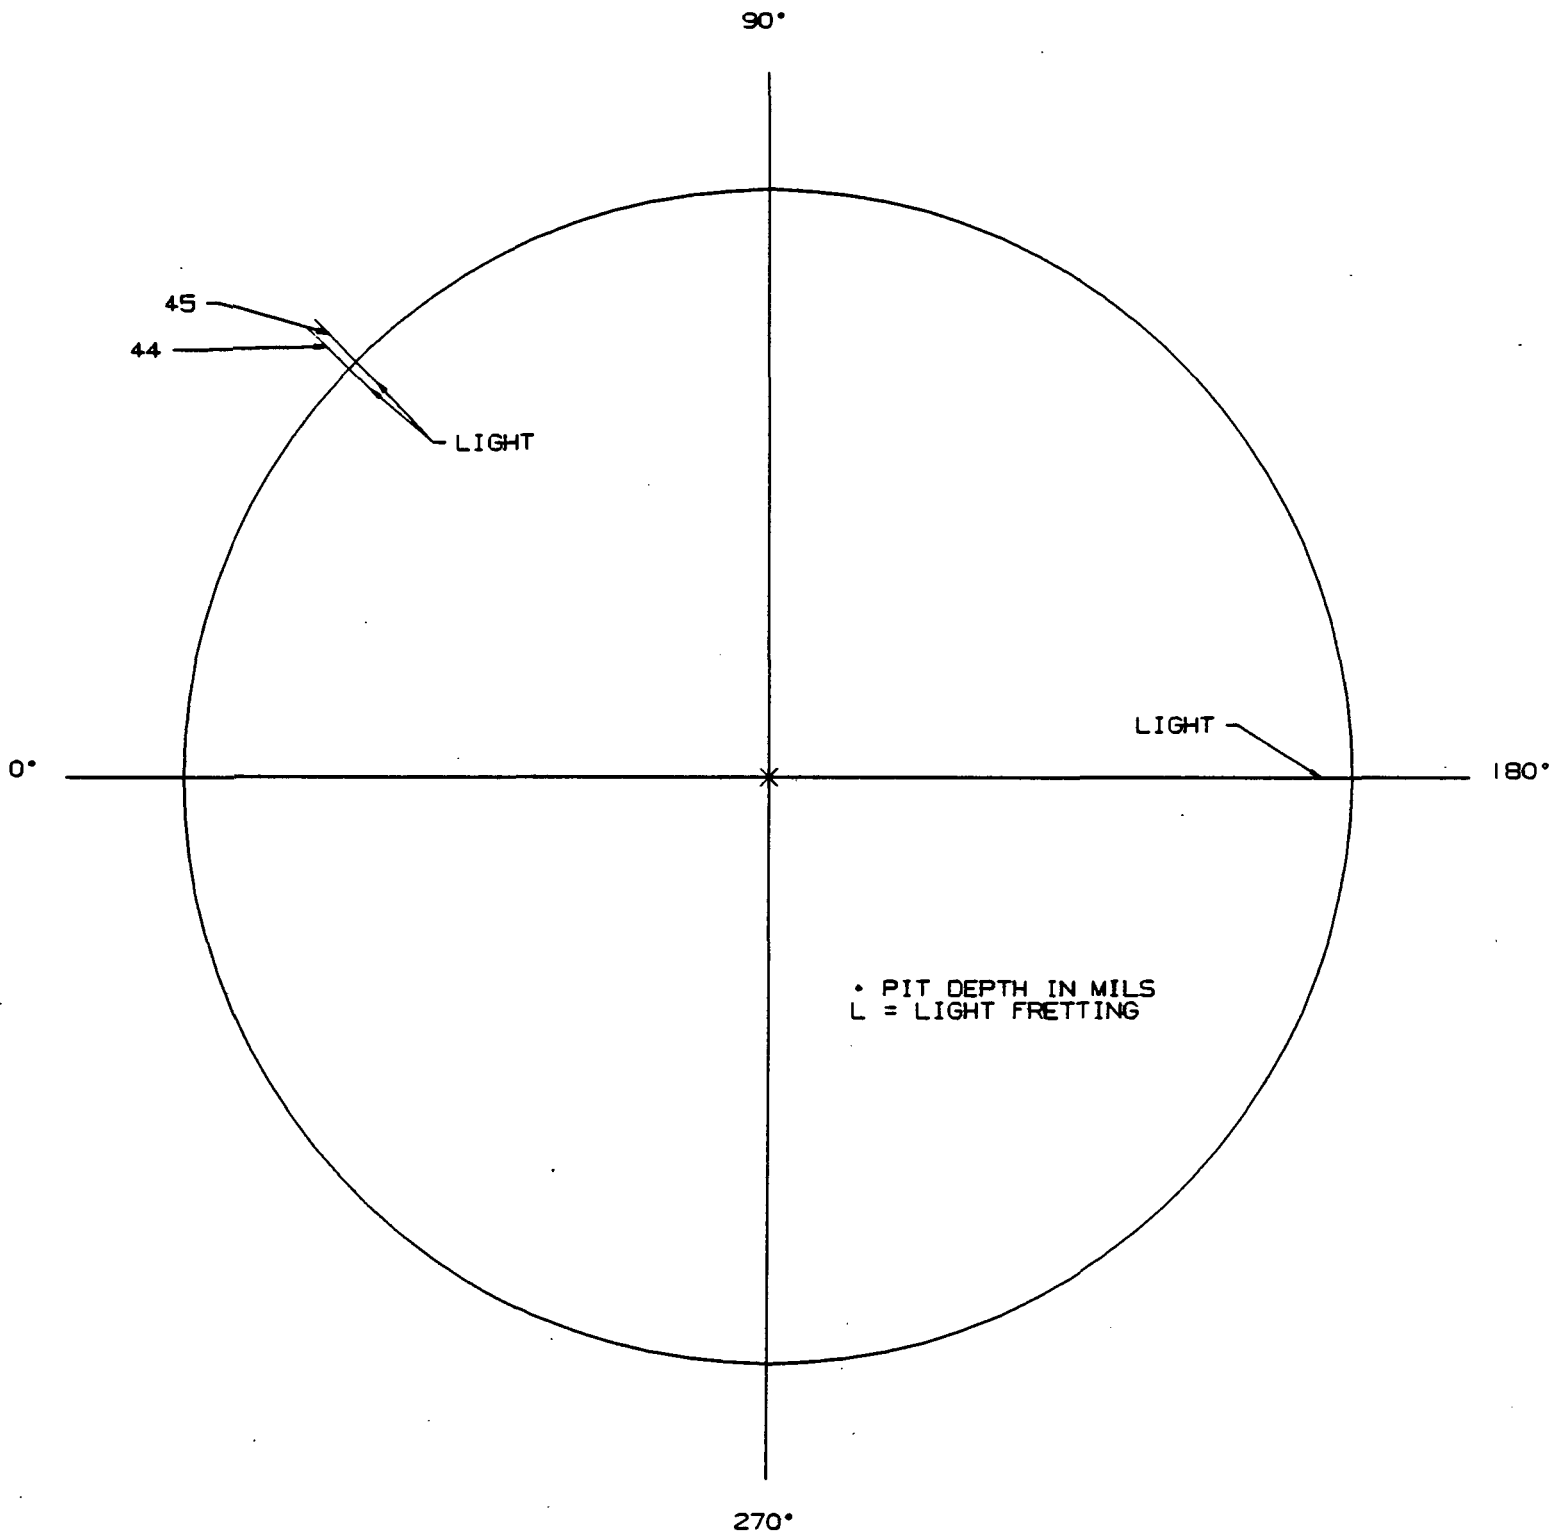
Figure 10 RH Forward Field Joint Fretting

Assessment of the metal components found light fretting at 44 and 45 degrees and a 0.004 inch deep fret at 180 degrees. Figure 10 gives a detailed view of the fretting.

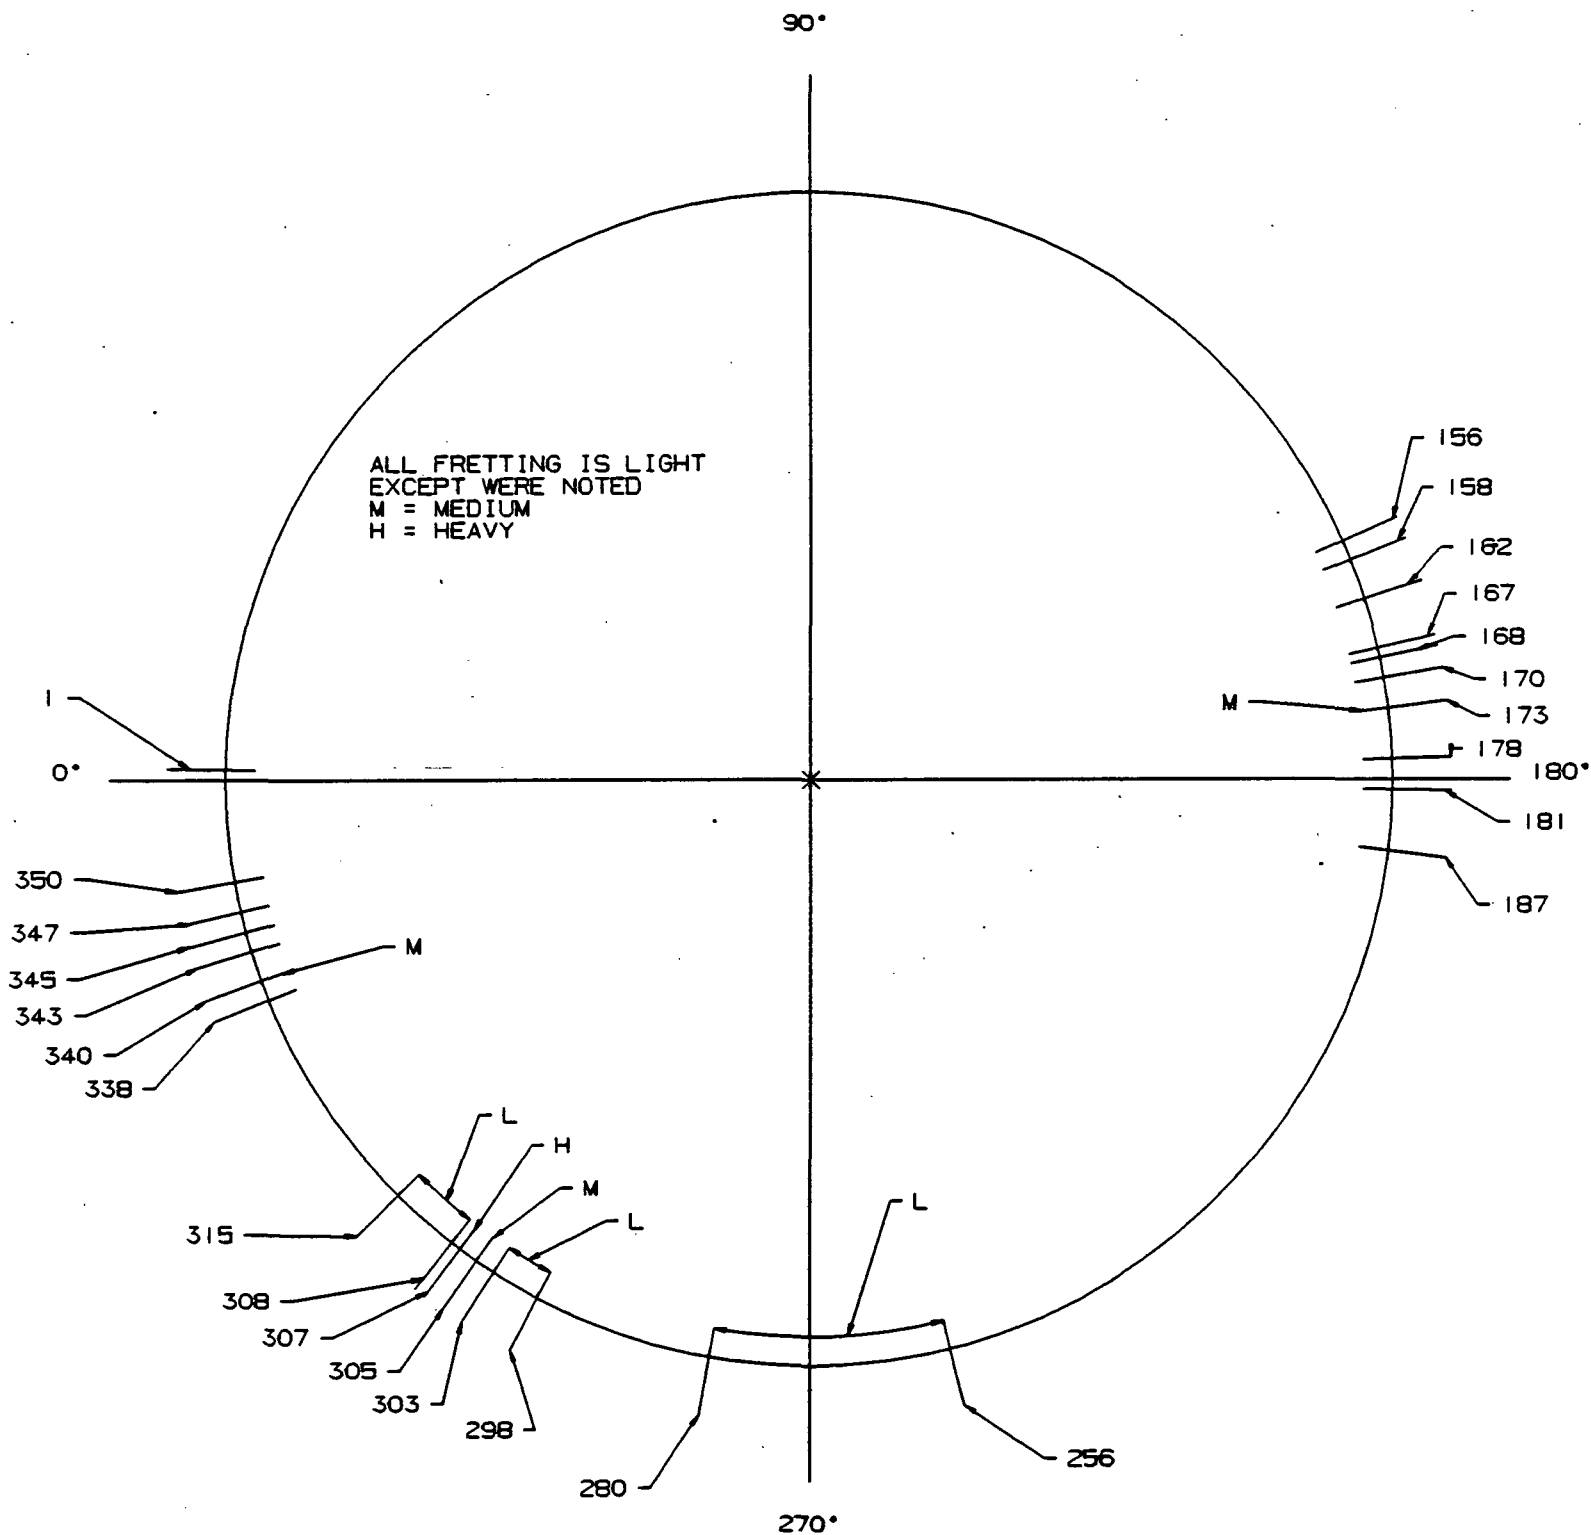
Figure 11 RH Center Field Joint Fretting

RH/CTR Light fretting from 156 to 187, 256 to 280, 298 to 315, and 338 through 0 to 1 degrees. Moderate (0.003 to 0.005 inch deep) fretting at 118, 305, and 340 degrees. A 0.009 inch deep fret was found at 350 degrees.

Assessment of the metal components found light fretting from 156 to 187, 256 to 280, 298 to 315, and 338 through 0 to 1 degrees. Moderate (0.003 to 0.005 inch deep) fretting at 118, 305, and 340 degrees. A 0.009 inch fret was found at 350 degrees. Figure 11 gives a detailed view of the fretting. Also, medium corrosion was present on the O.D. of the clevis from 86 to 92 degrees.

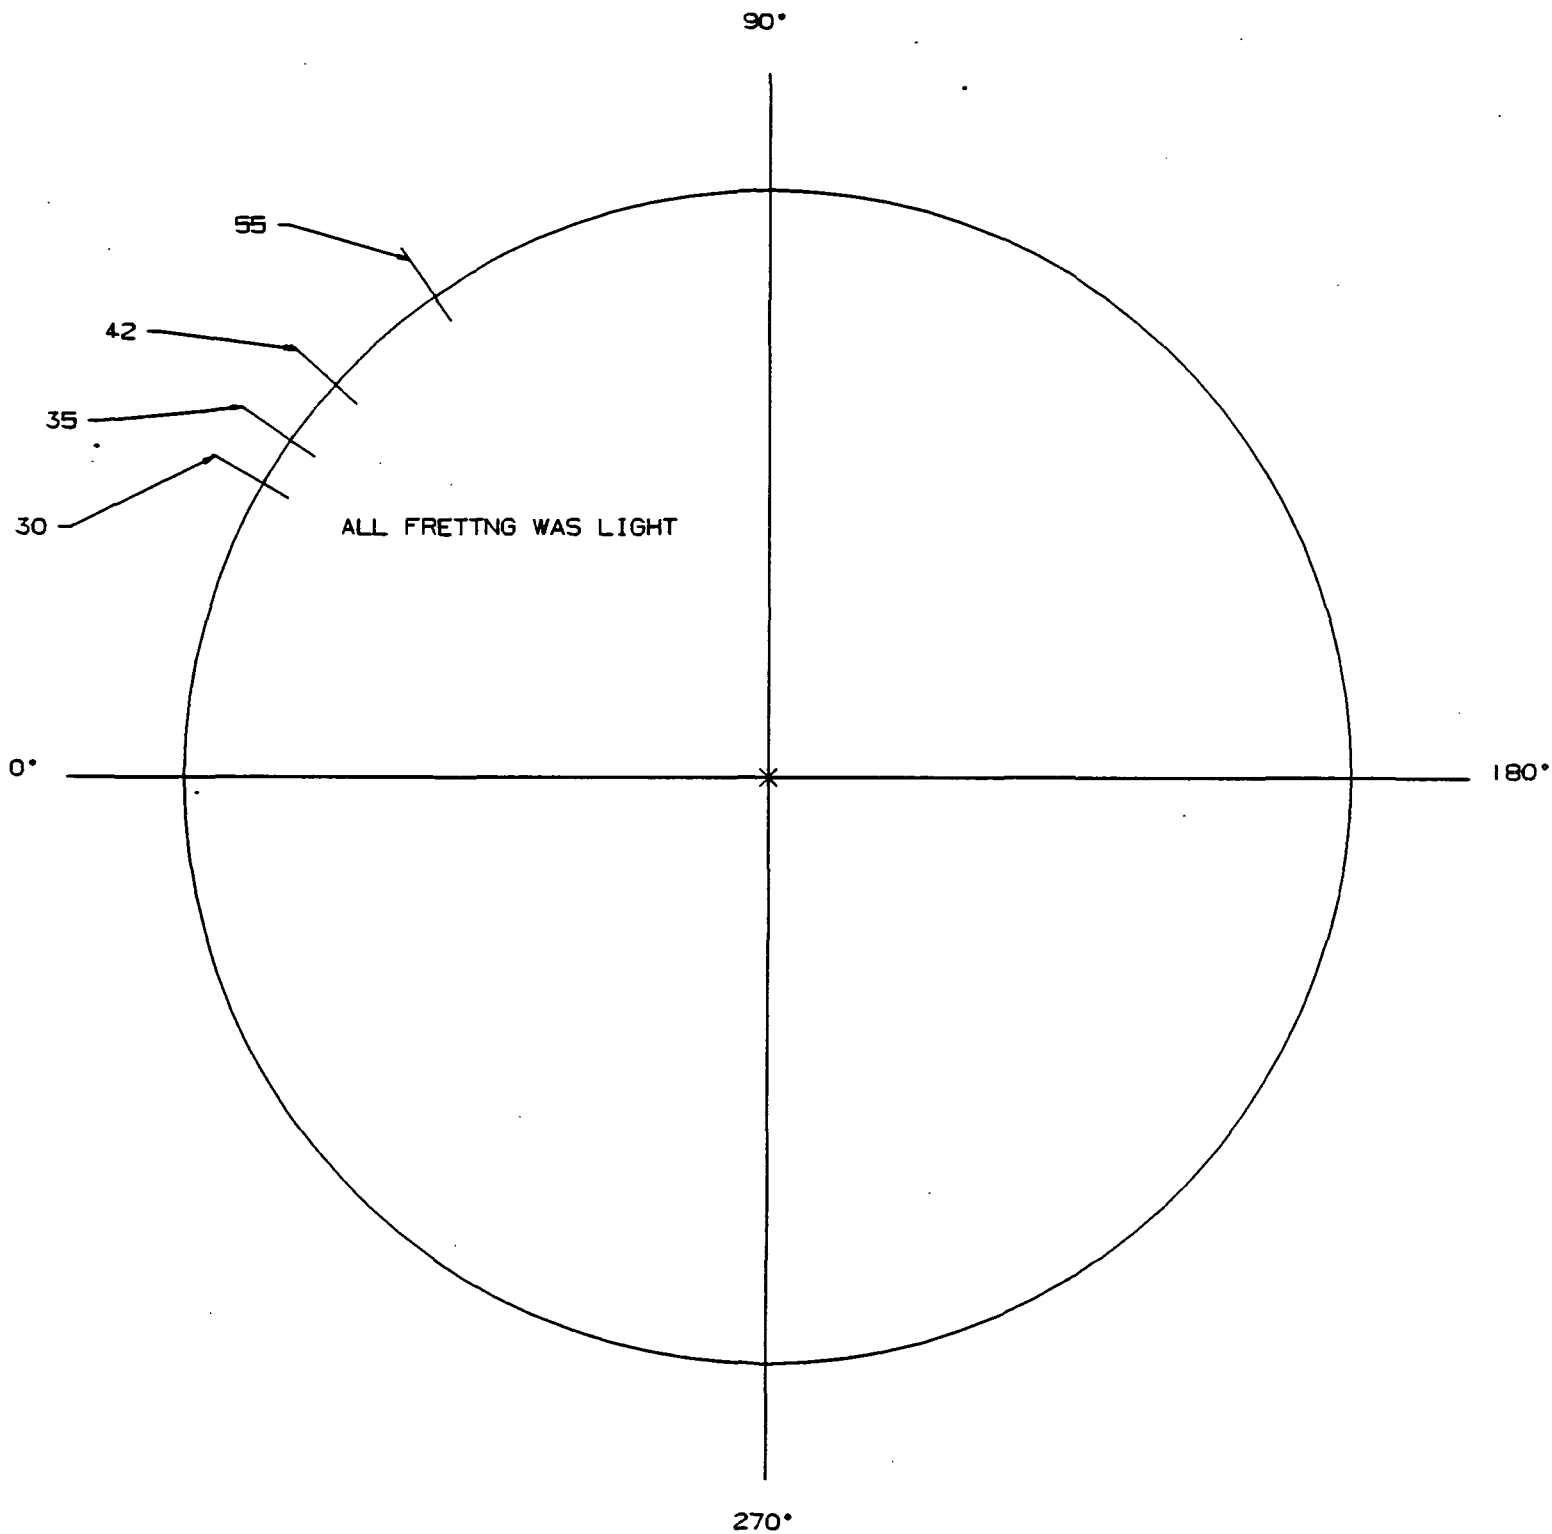
Figure 12 RH Aft Field Joint Fretting

Assessment of the metal components found light fretting at 30, 35, 42, and 55 degrees. Figure 12 gives a detailed view of the fretting.

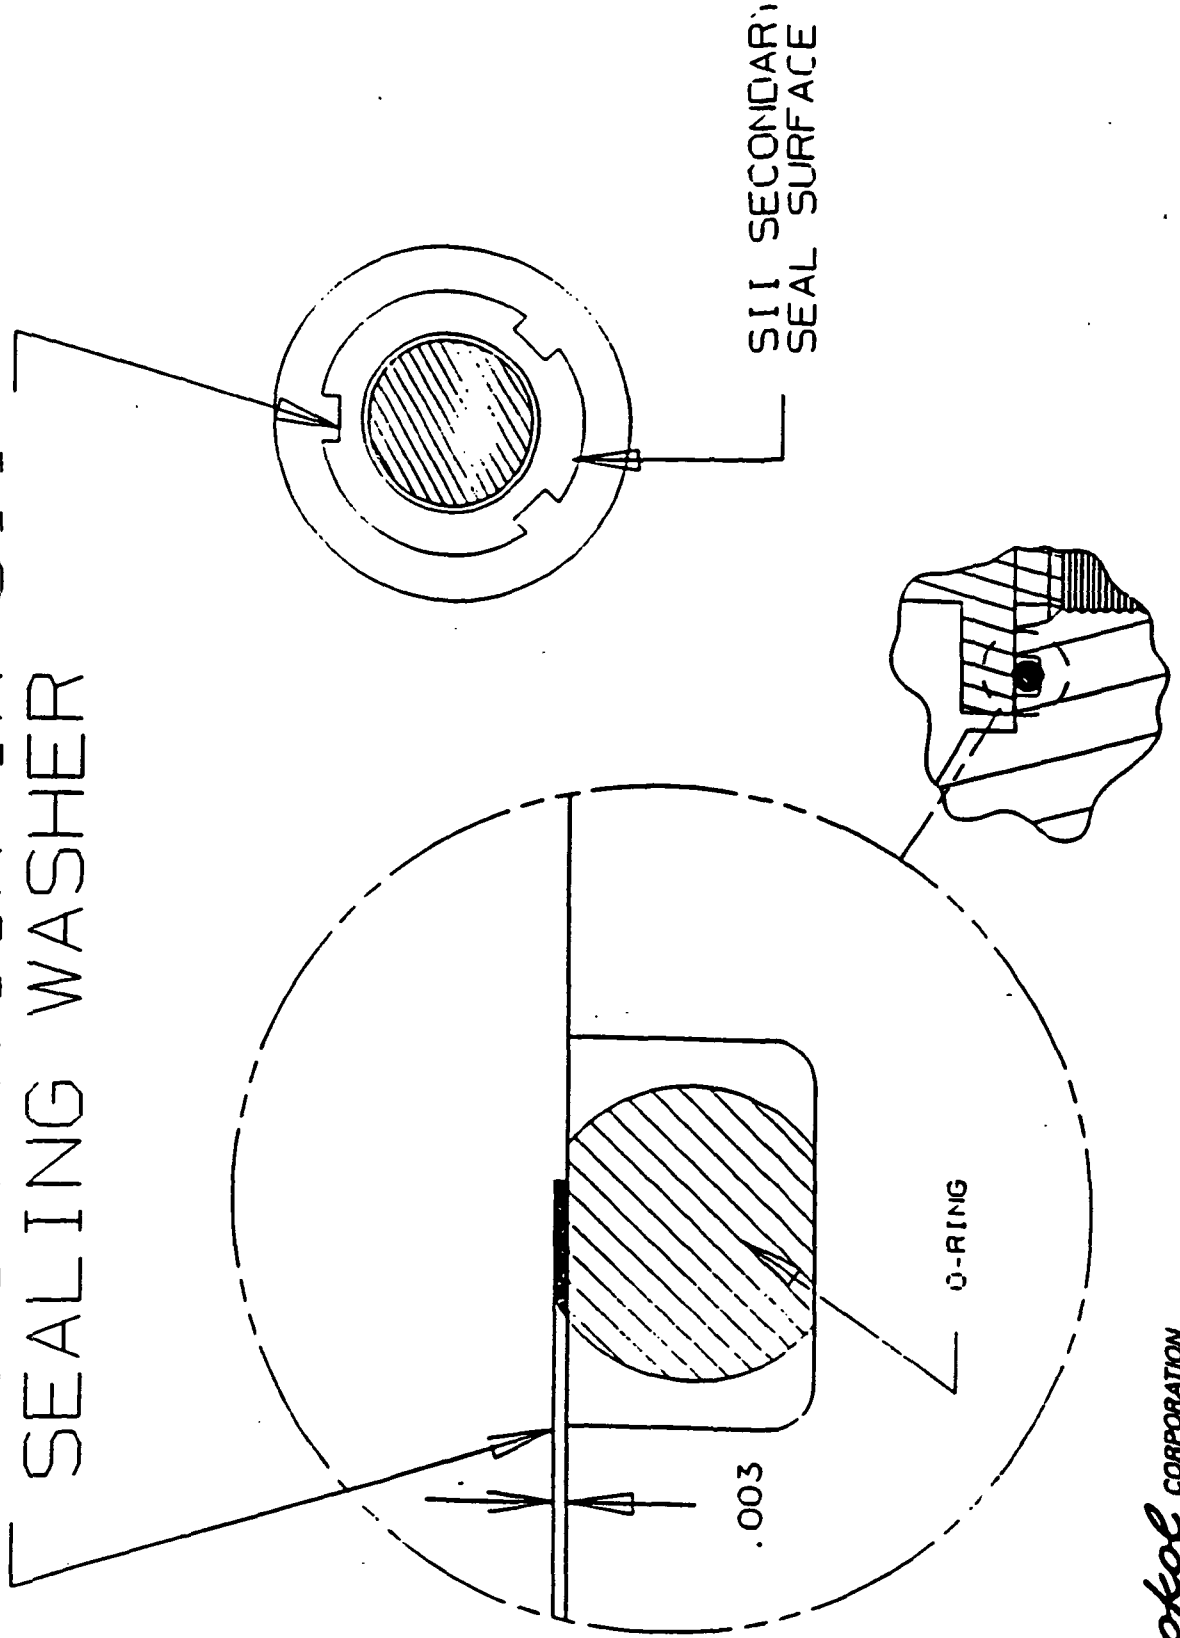
Assessment of the safe and arm device found deformations of the sealing washer of the 18 degree SII. A radial scratch across seal washer of the 18 degree SII was also found. Raised metal was present on the primary seal surface and the lead-in thread of the 198 degree SII port. Circumferential galling was found on the land between the primary and secondary seal surfaces of both SII ports. A closed radial flow line was found on the I.D. of the B-B leak test port plug O-ring. Circumferential galling was found on the seal surface of the Barrier Booster (B-B) and S&A leak check port plugs. Also, three deformations were present on the underside of the S&A leak check port plug, the largest deformation extended into the O-ring footprint.

DEFORMATION IN SII SEALING WASHER
